# Accessibility Audit Report

Holy Spirit Lutheran Church

Presented To  
**Sara Dorow**  
Vice President,  
Holy Spirit Lutheran  
Church Council

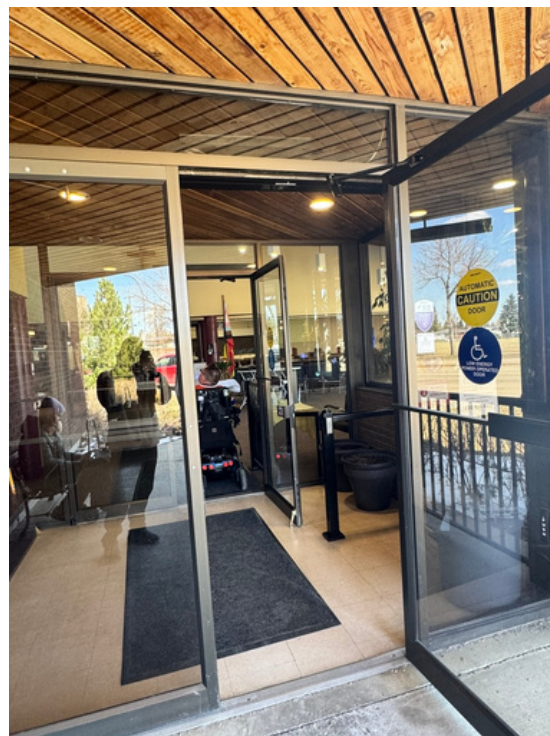
- **Accessible Parking Layout:** While accessible parking spaces are provided near the rear entrance, the adjacent access aisle is not clearly designated or protected from vehicle encroachment. This does not appear to meet current accessibility best practices for accessible parking design.

- **Winter Accessibility:** Ice accumulation and slippery conditions near the rear entrance, curb cut, and ramp areas may create barriers for wheelchair users, seniors, and individuals using walkers or other mobility aids.

- **Exterior Pathways:** Some exterior circulation routes require individuals using mobility devices to travel through parking areas due to the absence of additional curb cuts or clearly defined accessible pathways.

- **Rear Entrance Ramp Slope:** The existing rear entrance ramp was identified during the walkthrough as too steep for some wheelchair users and individuals with mobility limitations. Exact slope measurements were not taken during the audit and should be confirmed before determining whether modifications are required to meet current Alberta Building Code and CSA/ASC B651:23 expectations.

- **Accessible Parking Improvements:** Clearly identify and protect accessible parking access aisles through updated pavement markings, signage, and painted buffer areas to reduce vehicle encroachment and improve maneuverability. Current Alberta accessibility requirements identify an accessible parking stall as **2.4 metres wide adjacent to a 2.4 metre wide access aisle**. The access aisle should be clearly marked as a No Parking Zone and remain free of obstructions at all times. Accessible parking areas should also include a firm, slip-resistant surface, vertical accessible parking signage, and the International Symbol of Access painted on the pavement.

- **Barrier-Free Pathway Enhancements:** Continue planned pathway upgrades to create a safer and more clearly defined accessible route from parking areas to the building entrances. Future improvements should consider pathway width, surface stability, slope, cross-slope, curb cut placement, and overall ease of travel for wheelchair users, seniors, and individuals using mobility aids.

- **Rear Entrance Ramp Review:** Review rear-entrance ramp slope, landings, handrails, edge protection, and winter maintenance against current Alberta Building Code and CSA/ASC B651:23 expectations. If a portable ramp is used as an interim measure, confirm slope, stability, edge protection, supervision, and safe storage. Prefer a permanent curb cut or built accessible route where feasible.

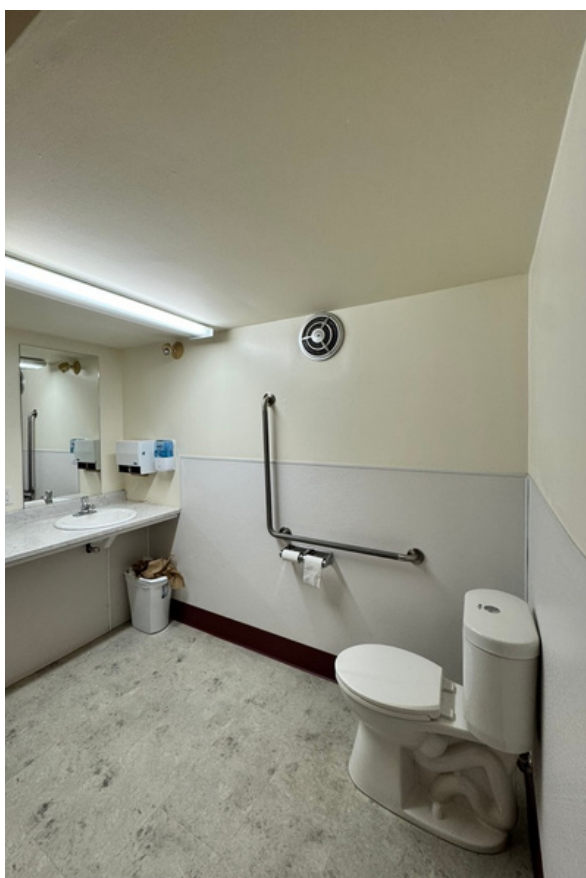
Although the washrooms have been improved, they may not fully accommodate all persons with disabilities, especially individuals who use larger power wheelchairs, scooters, walkers, or who require additional maneuvering space.

- **Maneuvering Space:** Some washroom areas may not provide adequate maneuvering space for persons who use larger wheelchairs or scooters.
- **Door Hardware:** Some washroom doors are equipped with round doorknobs. Lever-style hardware would provide better access for persons with limited hand strength or dexterity.
- **Sink Access:** Protective coverings below some sinks may limit knee clearance for persons who use wheelchairs.
- **Grab Bars:** Existing grab bars should be reviewed to confirm that they meet current Alberta Building Code and CSA/ASC B651:23 requirements.

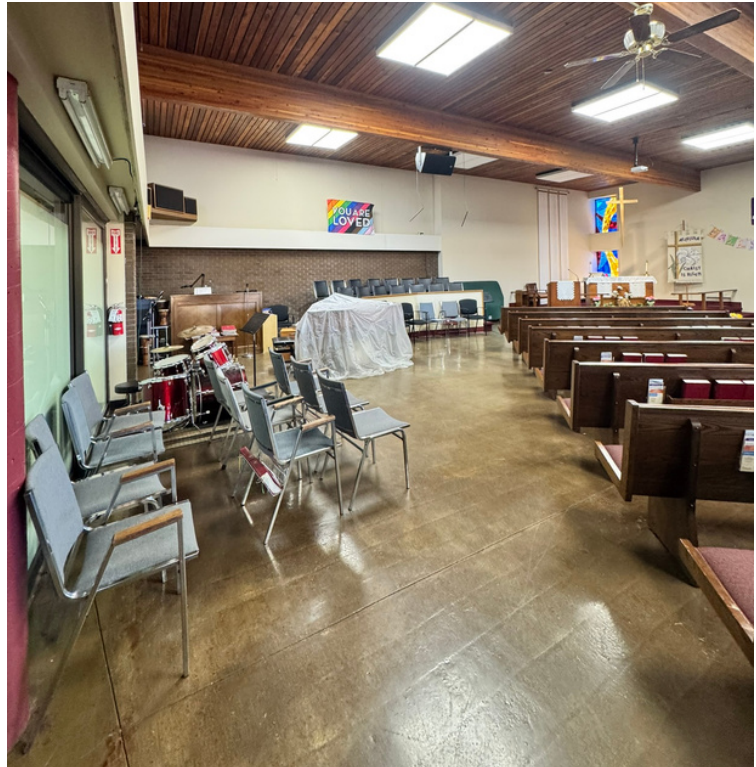
- **Visual Accessibility:** Individuals with low vision may experience challenges reading projected materials, worship bulletins, hymn lyrics, or presentation screens depending on seating location, lighting conditions, and font size.

- **Floor Surface and Slip Resistance:** The sanctuary floor surface is highly polished and reflective. While visually appealing, the finish may create glare for individuals with low vision and may become slippery under certain conditions for seniors, wheelchair users, and individuals using mobility aids.

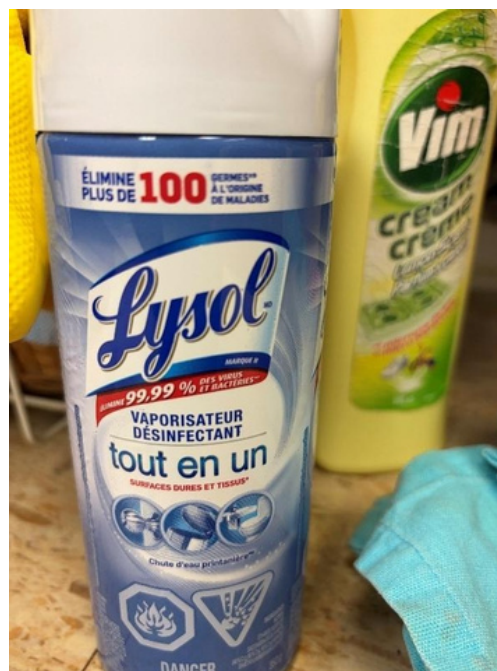
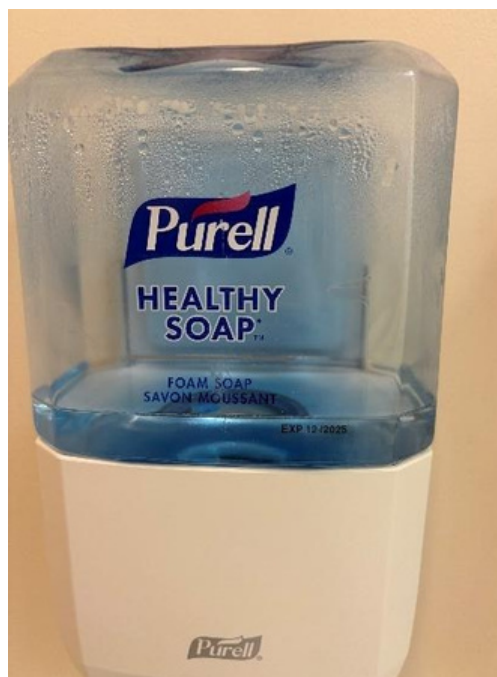
- Fragranced Products:** Several cleaning and maintenance products reviewed during the audit contained fragrance or parfum ingredients. These products may create barriers for individuals with environmental sensitivities, fragrance intolerance, asthma, migraines, respiratory conditions, autoimmune conditions, and other health conditions.

- Chalk Dust Exposure:** A chalkboard was observed within one of the smaller rooms. Chalk dust may contribute to respiratory irritation and reduced indoor air quality, particularly for individuals with asthma, allergies, environmental sensitivities, and other respiratory conditions.

- Aerosol Products:** Aerosol-based products may contribute to indoor air pollution and introduce unnecessary fragrances or airborne irritants into shared spaces.

- **Fragrance-Free Product Transition:** Gradually replace existing fragranced cleaning products, soaps, aerosol products, and related supplies with fragrance-free alternatives as current inventories are depleted. Future purchasing decisions should prioritize fragrance-free products whenever practical to reduce unnecessary exposure for individuals with environmental sensitivities, respiratory disabilities, autoimmune conditions, and immunocompromised systems.

- **Chalkboard Replacement:** Replace existing chalkboards with whiteboards or other low-dust alternatives to reduce airborne particles and improve indoor air quality, particularly in smaller enclosed rooms.

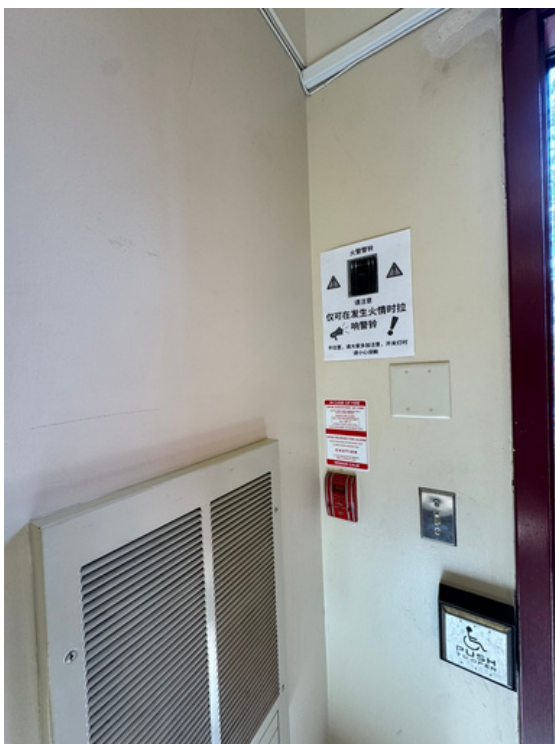
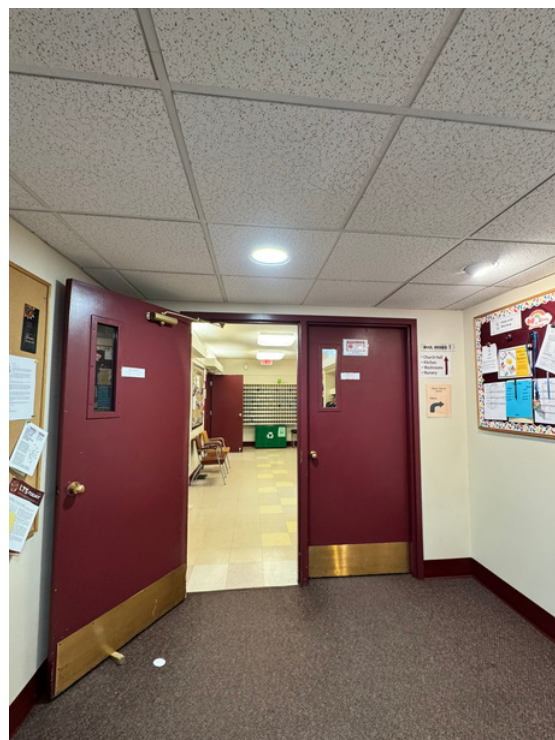
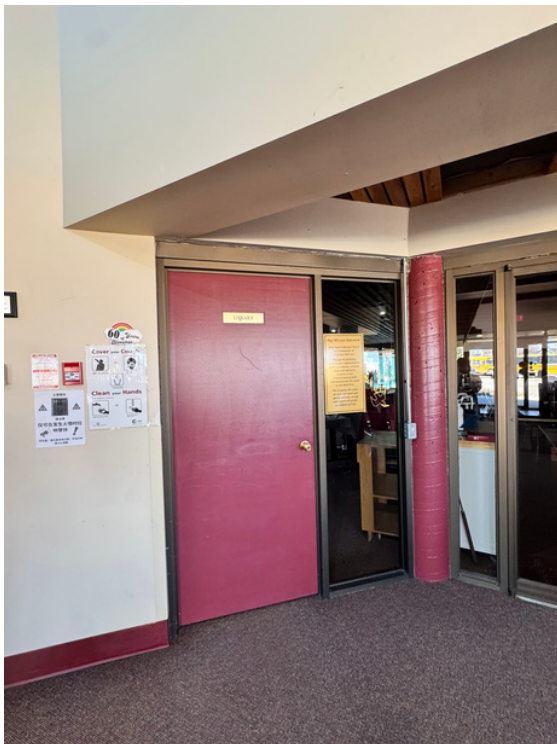
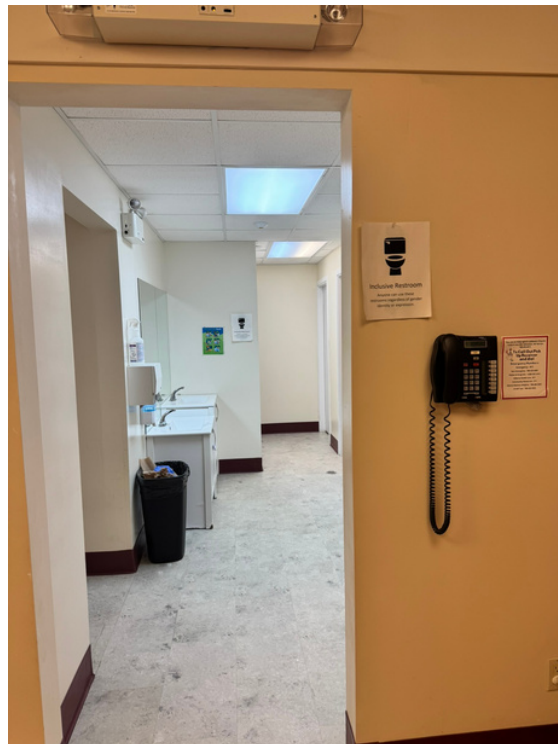
Wayfinding and signage at the Church are inconsistent. Some rooms and functions are clearly identified while others, including washrooms, meeting rooms, storage areas, emergency features, and exterior arrival points, may be difficult for first-time visitors or people with low vision, cognitive disabilities, or language barriers to identify. During the walkthrough, the team discussed room-name confusion, legally blind attendees, fire alarm/light-switch confusion, dark flooring blending with pews, and the need for clearer interior and exterior cues.

- **Wayfinding and Signage Specialist:** Consider retaining a wayfinding/signage professional to create a phased, church-scaled system for entrances, washrooms, sanctuary access, meeting rooms, emergency features, daycare routes, accessible parking, drop-off/loading, and the garden/play area.

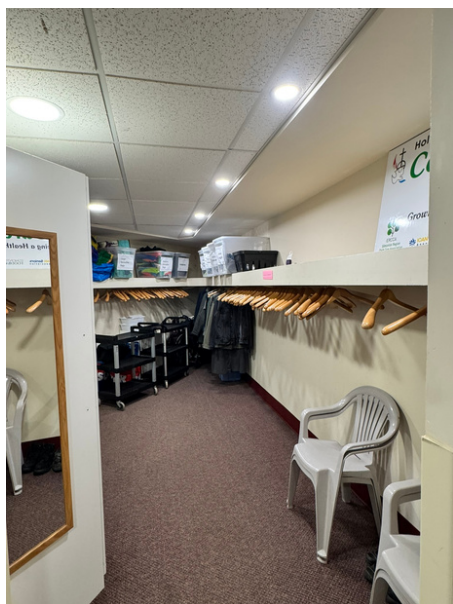
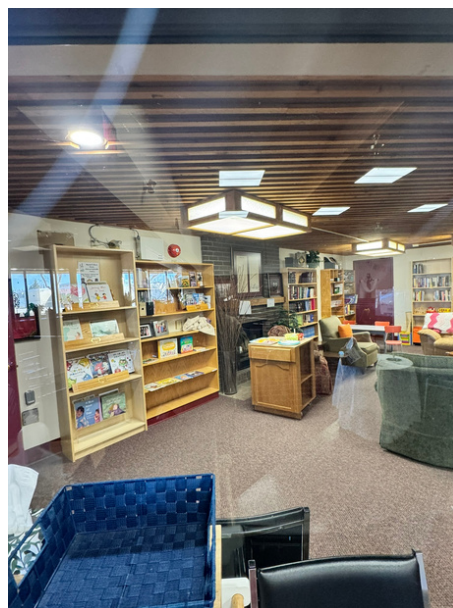
The library and some smaller meeting spaces have limited maneuvering room due to furniture placement and storage requirements. While these spaces remain usable, accessibility may be improved through future space planning and furniture adjustments.

- **Accessible Seating Locations:** Identify and maintain designated accessible seating locations within meeting rooms, classrooms, and gathering spaces to ensure individuals using wheelchairs, walkers, or other mobility devices can participate without requiring furniture to be rearranged at the time of an event. Accessible seating locations should be integrated throughout gathering spaces wherever possible to allow individuals using mobility devices to sit alongside family members, friends, and support persons.

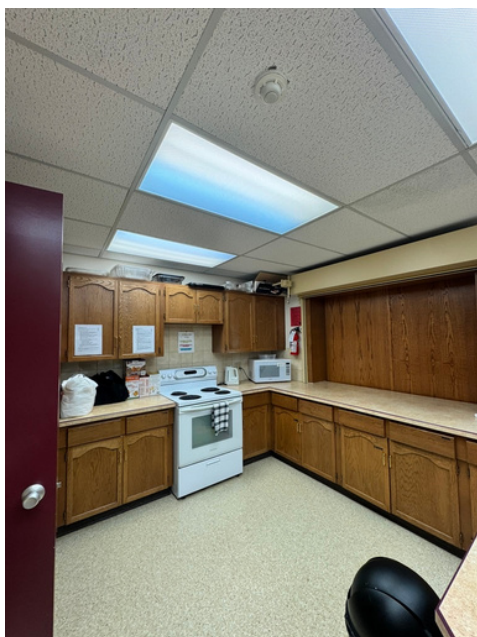
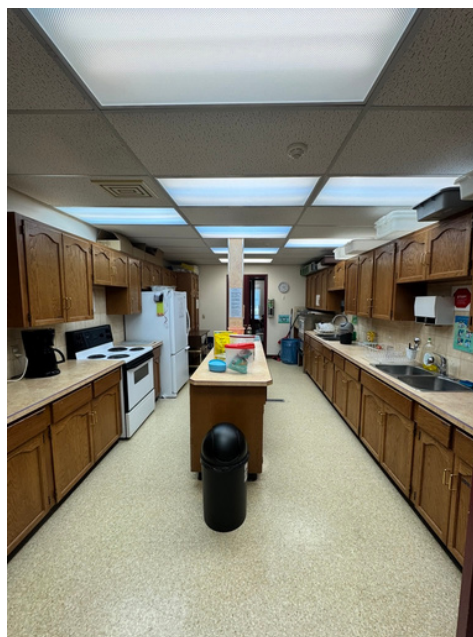
While the kitchen is functional for many users, some work surfaces, storage locations, and equipment may be difficult to access for individuals using wheelchairs or those with limited reach. Upper cabinets and some storage areas may not be accessible to all users without assistance.

- **Future Accessibility Planning:** Incorporate accessibility considerations into future kitchen renovations, equipment replacement, and space planning initiatives in accordance with universal design principles, Alberta Building Code requirements, and CSA/ASC B651:23 best practices.

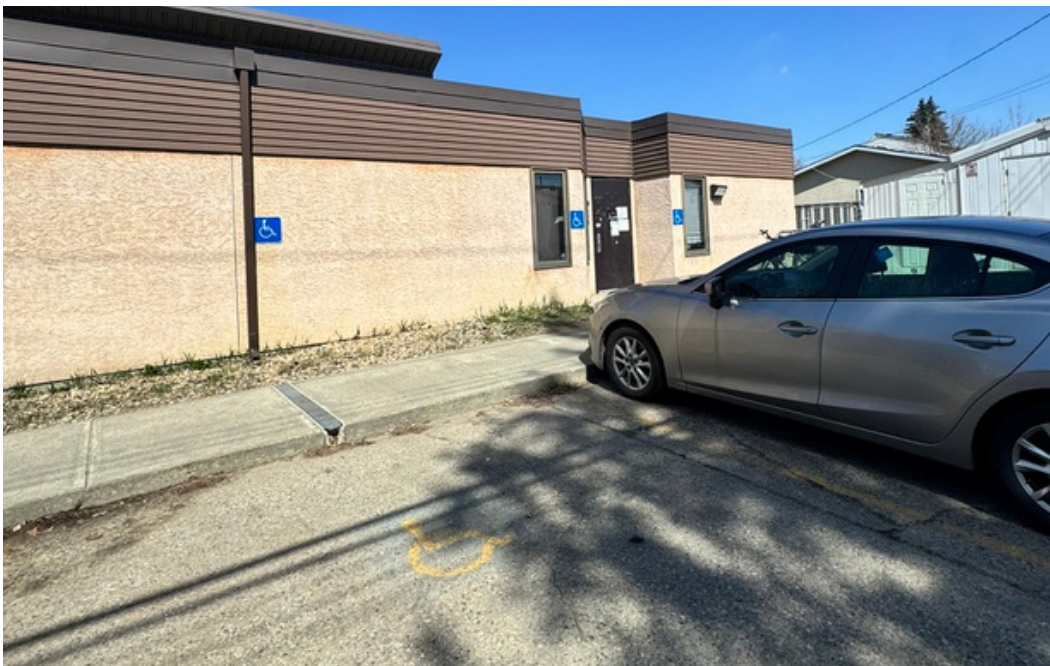
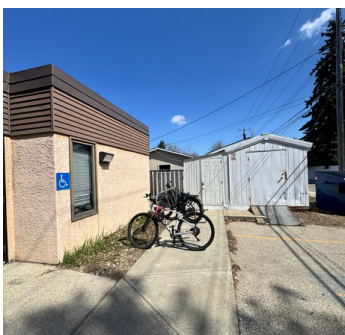
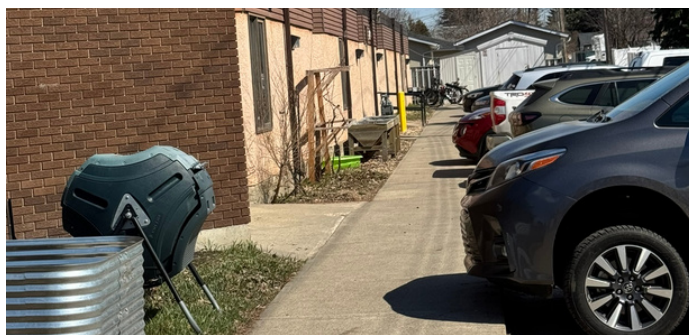
Holy Spirit Lutheran Church includes outdoor spaces that support community participation, recreation, gardening, and daycare programming. These spaces include raised garden beds, pedestrian pathways, outdoor gathering areas, and a children's play area.

A significant strength of the outdoor area is the community garden, which includes raised garden beds designed to improve accessibility for individuals who may have difficulty gardening at ground level. The outdoor spaces provide opportunities for social interaction, recreation, and community engagement for congregation members, volunteers, daycare participants, and visitors.

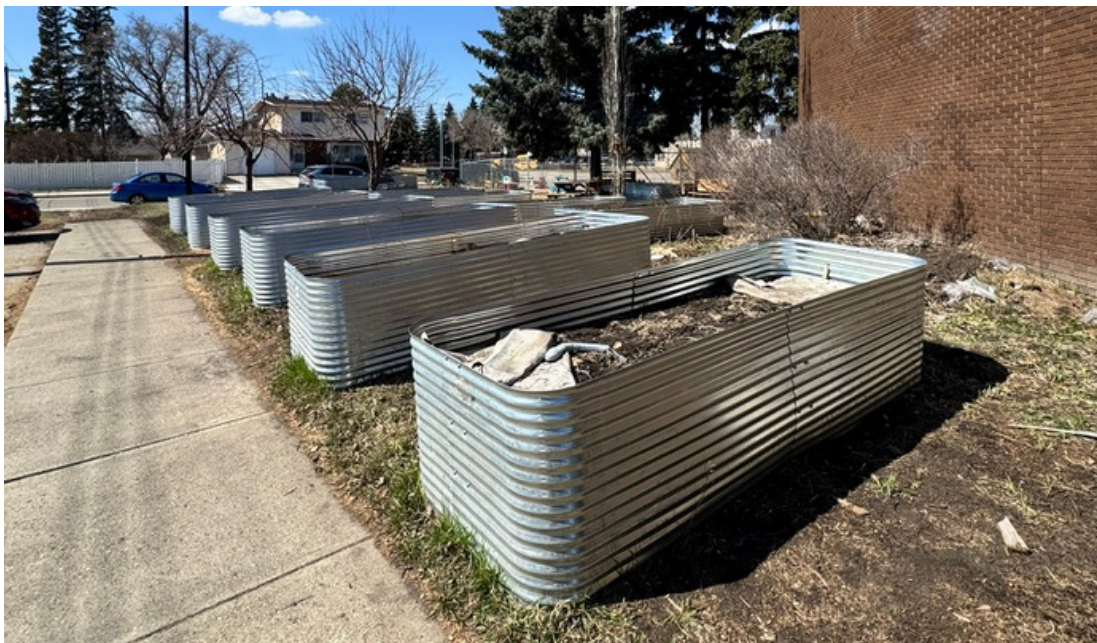
The pathway connecting the parking area, garden spaces, and children's play area presents accessibility challenges. Existing surfaces may be difficult for wheelchair users, walkers, strollers, and individuals with balance or mobility limitations, particularly during winter conditions.

While outdoor seating opportunities exist, additional rest areas may benefit seniors and individuals who require periodic breaks when travelling between parking areas, entrances, gardens, and activity spaces.

Snow storage locations may also impact accessibility during winter months if pathways, curb cuts, or accessible routes become obstructed by accumulated snow.

- **Accessible Pathway Improvements:** Develop an accessible pathway connecting the parking lot, garden area, and children's play space. The route should be firm, stable, slip-resistant, well-drained, winter-maintainable, and usable for wheelchairs, walkers, strollers, and daycare wagons. Avoid loose mulch, decorative stone, or uncompacted gravel as the primary accessible route.

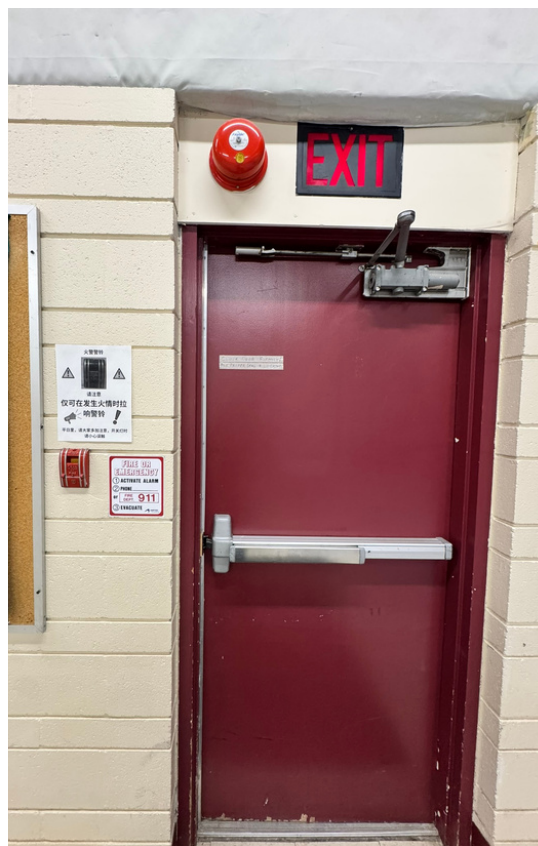
Winter conditions may also impact emergency egress routes. Snow accumulation, ice, and reduced visibility can create additional barriers for individuals attempting to access muster points or navigate exterior routes during an emergency.

The parking lot and outdoor circulation routes present accessibility challenges that could affect evacuation efficiency, particularly for individuals using mobility devices who rely on curb cuts, accessible parking areas, and unobstructed pedestrian pathways.

- **Accessibility and Capacity:** Ensure that the Areas of Refuge are accessible and spacious enough to accommodate at least two wheelchair users, while still allowing passage for other individuals.

- **Signage and Communication Systems:** Install clear signage to easily identify the Areas of Refuge and equip them with communication systems for emergency contact.
